UNDERWATER FACILITIES  
INSPECTION &  
ASSESSMENTS  
NAVAL STATION CHARLESTON, SC.

The objective of the underwater facility assessments conducted at the U.S. Naval Station in Charleston, South Carolina is to provide a generalized structural condition report of designated facilities within the activity.

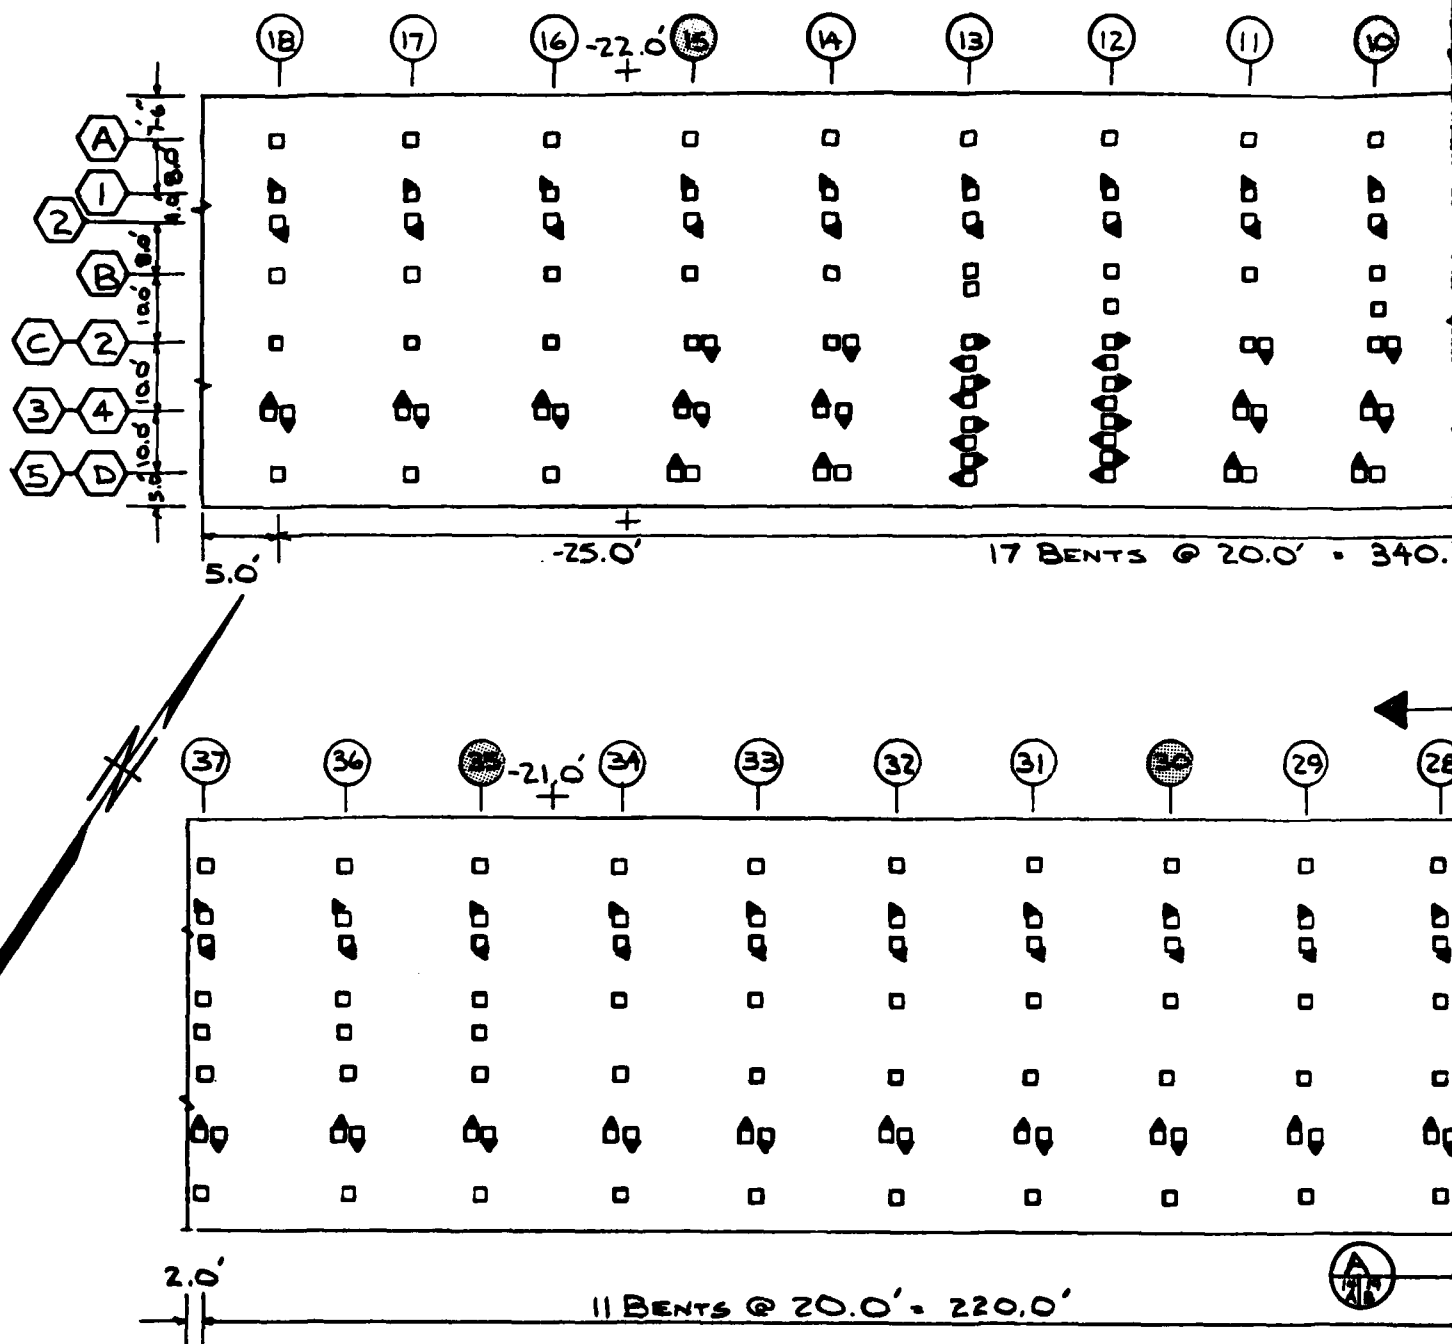
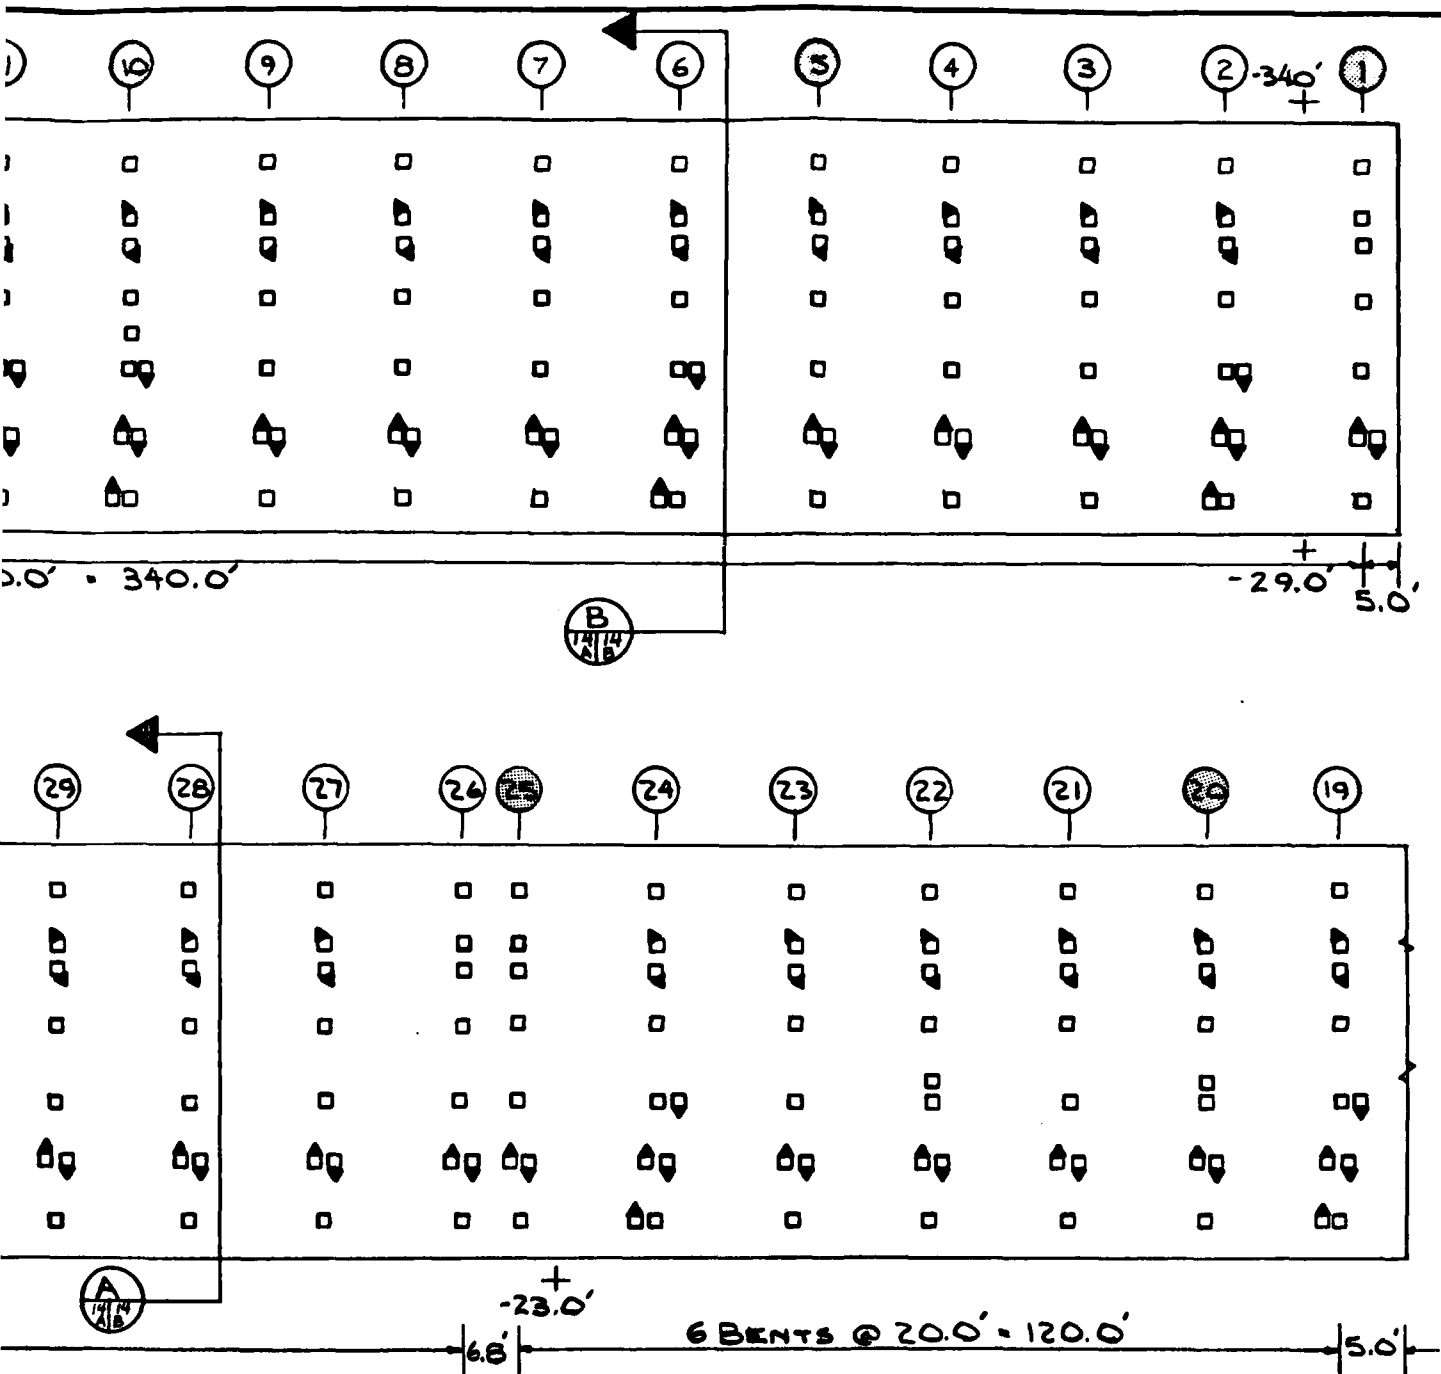
GRAPHIC SCALE		CHESAPEAKE DIVISION NAVAL FACILITIES ENGINEERING COMMAND WASHINGTON, D.C.	
5' 0"	10' 20' 30' 40'	NAVAL STATION	CHARLESTON, SC
		PIER QUEBEC	PIL. NO. 14A

On the northern half of the pier, approximately 5% of the piles had hairline cracks around mean low water (MLW). From Bents 26 to 45, around 20% of the piles had one or two 1/8" wide cracks running from 2 feet below the pile cap to mudline. No rusting or reinforcing was visible. There was occasional cosmetic spalling on the corners.

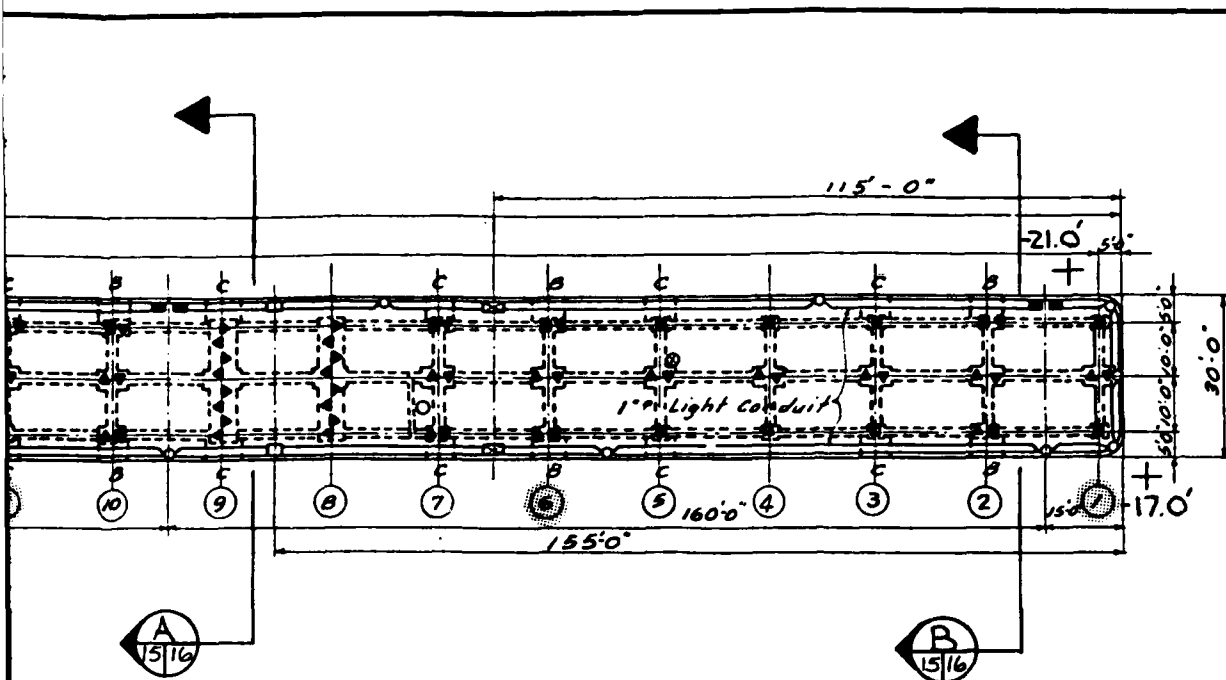
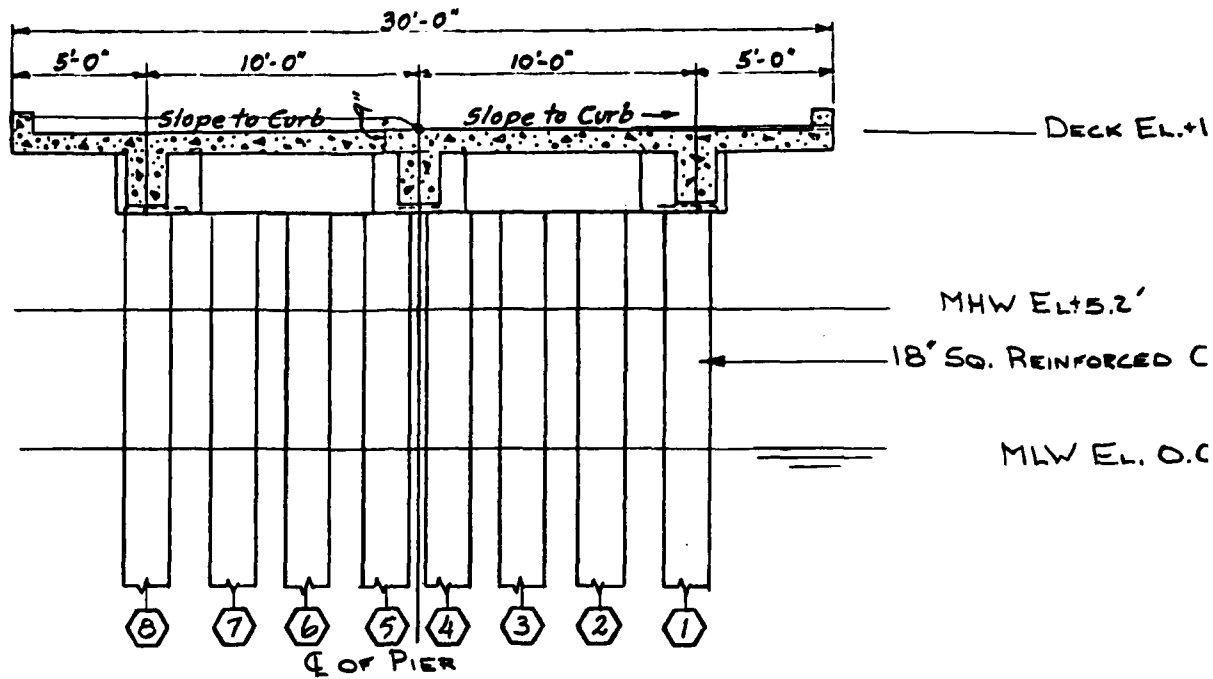
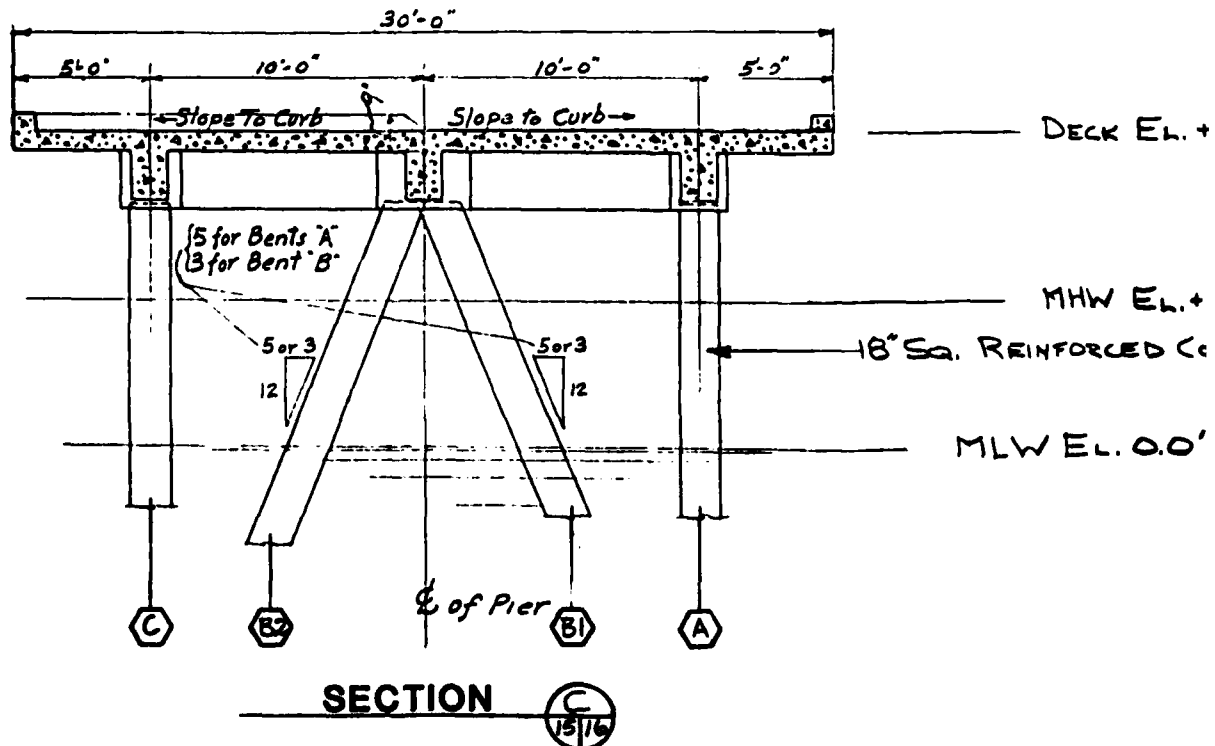
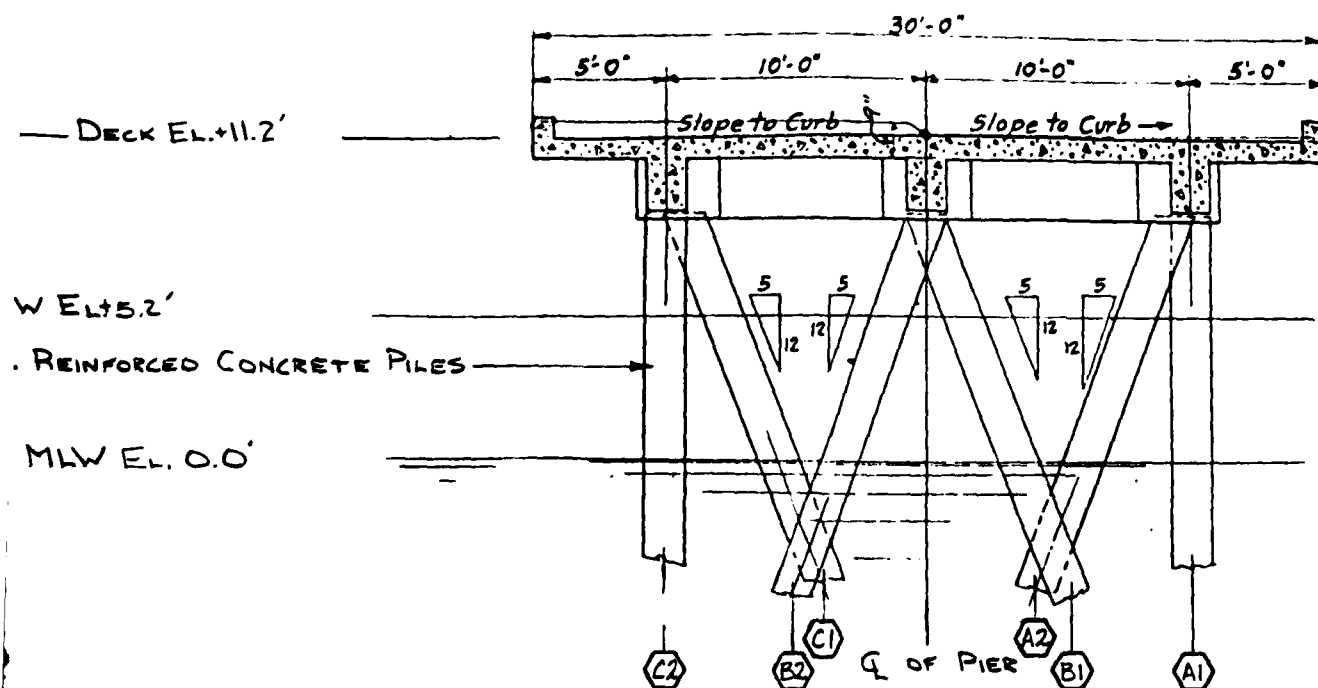
B  
15/16

Generally, all the piles in Pier ROMEO had cracks up to 1/16" in width running from near the pile cap down to mean low water (MLW). Around 40%, however, had cracks up to 1/4" wide. Spalling and 1" - 2" of softness were common in the areas of cracking (see Photo #10). In the MLW area, there was generally 1/2" of softness in the concrete.

About 5% of the piles evidenced more severe spalling (2" - 6" deep) in the region from the pile cap to MLW (see Photo #11). The concrete was soft in areas of spalling (1" deep). Half of these piles had reinforcing exposed. All these piles were located on the inshore perimeter of the pier (from Bents 26 to 35).

Pier ROMEO is in good condition except for some areas of heavy spalling on various exterior piles in Bents 1 to 10. This localized heavy spalling is probably due to the location of these piles since they are completely exposed at low tide and are prone to impact damage. Air temperatures are more variable and have greater extremes than water temperatures. Therefore, during cold weather, any water inside the pile is more apt to freeze when the pile is exposed to air temperatures. The result is spalling and cracking of the concrete which can shorten the expected life of these piles. Repairs to protect concrete piles from further deterioration is the best solution.

It is recommended that all cracks greater than 1/32" wide and all spalled areas greater than 1" deep be repaired to protect them from further deterioration. The estimated cost for these repairs is \$36,000.

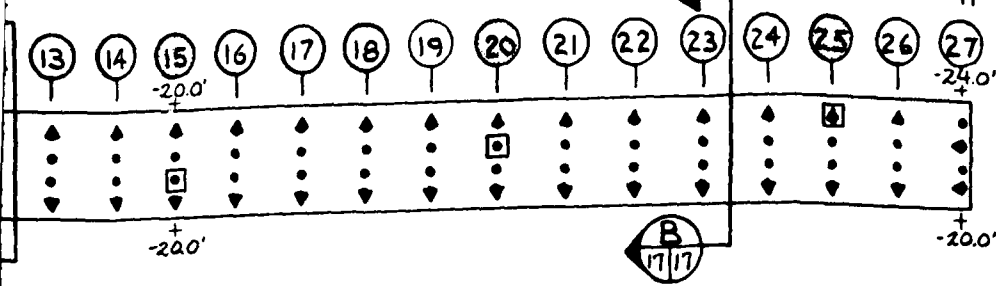
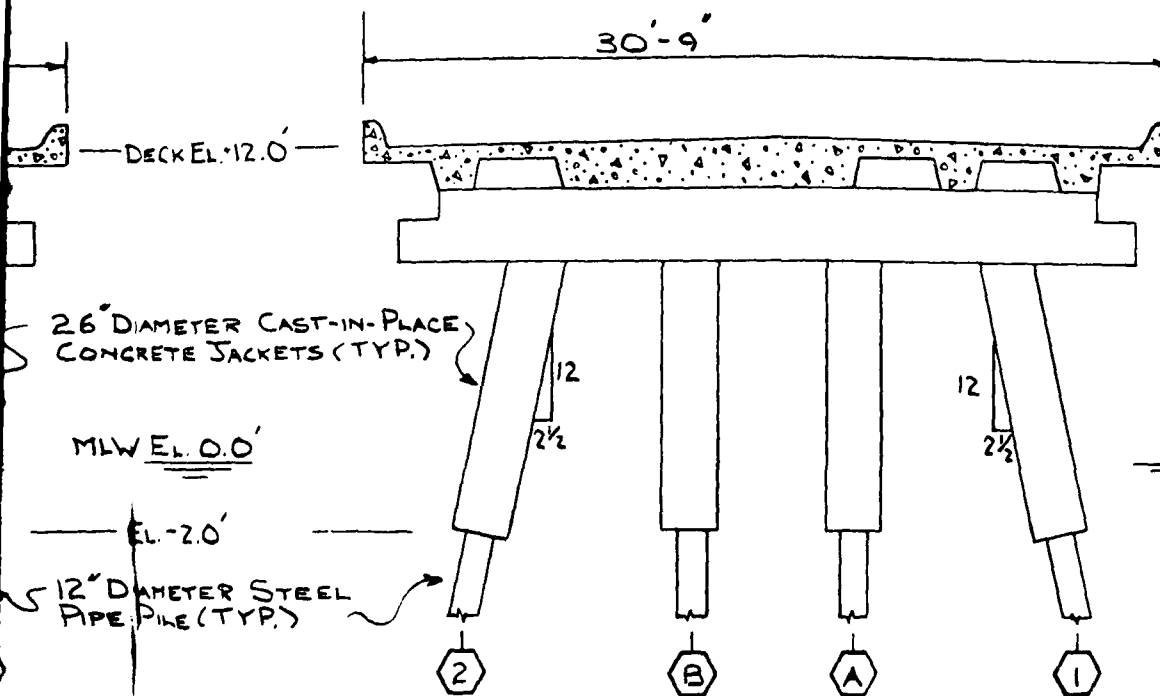
The only damage observed occurred in Bent 2. The concrete jacket on Pile 1 had a 1/2" wide horizontal crack around its circumference, 6 feet below the pile cap. There were no other signs of damage. An 18" square concrete pile had been driven just south of and adjacent to Pile 1 (see Figure 17).

Ultrasonic thickness measurements taken on five piles indicated a range in metal loss due to corrosion from 0% to 28% (see Appendix for actual thickness measurements). The steel itself was lightly pitted.

Pier SIERRA is in excellent condition. No structural deterioration has occurred to reduce the capacity of this pier. Metal loss due to corrosion is insignificant.

The crack in the concrete jacket should be filled with an epoxy grout to protect the steel pile from corrosion. The estimated cost for this repair is \$500.
